NASA Technical Memorandum 85679

VERTICAL DROP TEST OF A TRANSPORT FUSELAGE
SECTION LOCATED FORWARD OF THE WING

M. Susan Williams
Robert J. Hayduk

August 1983

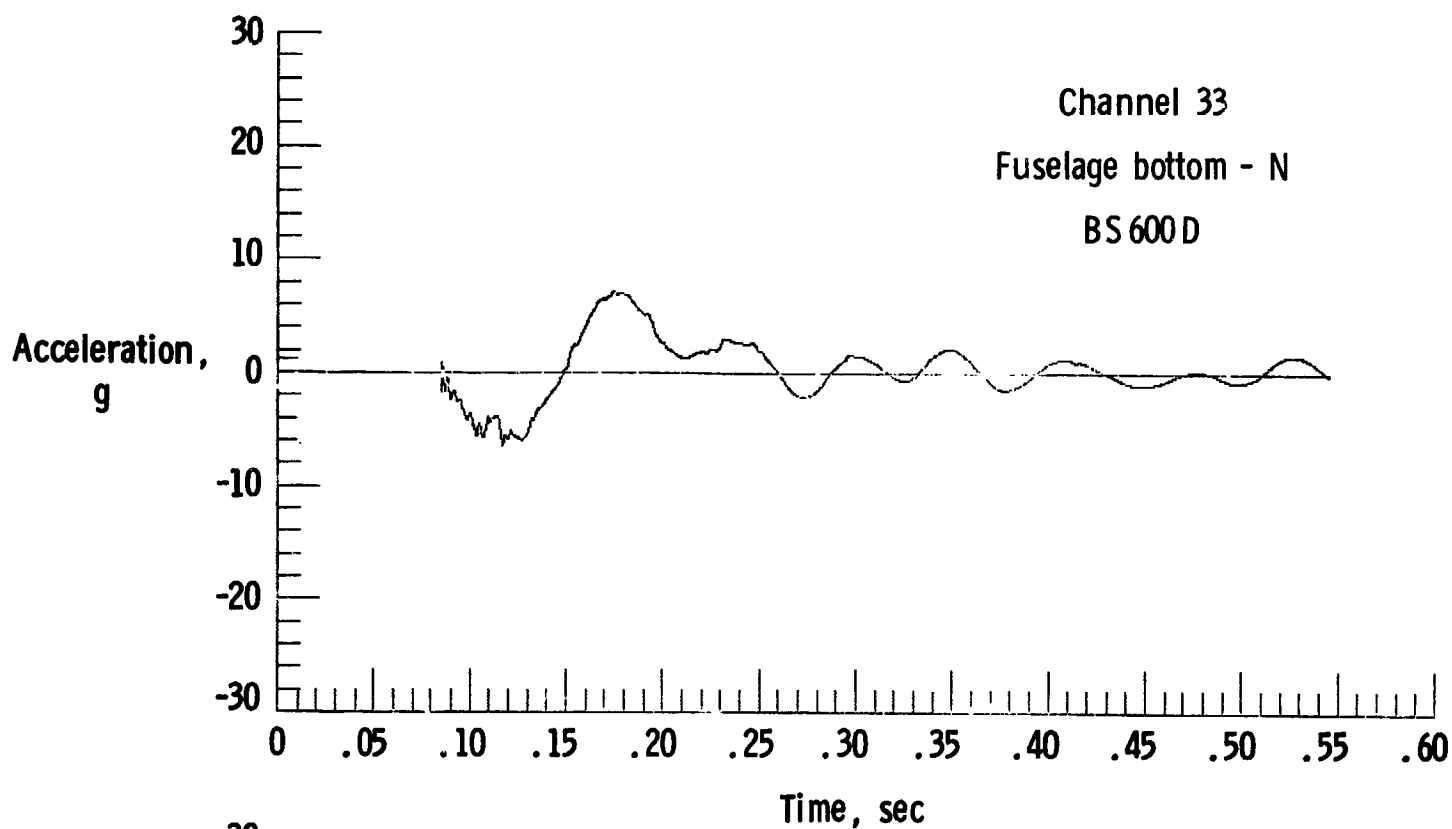
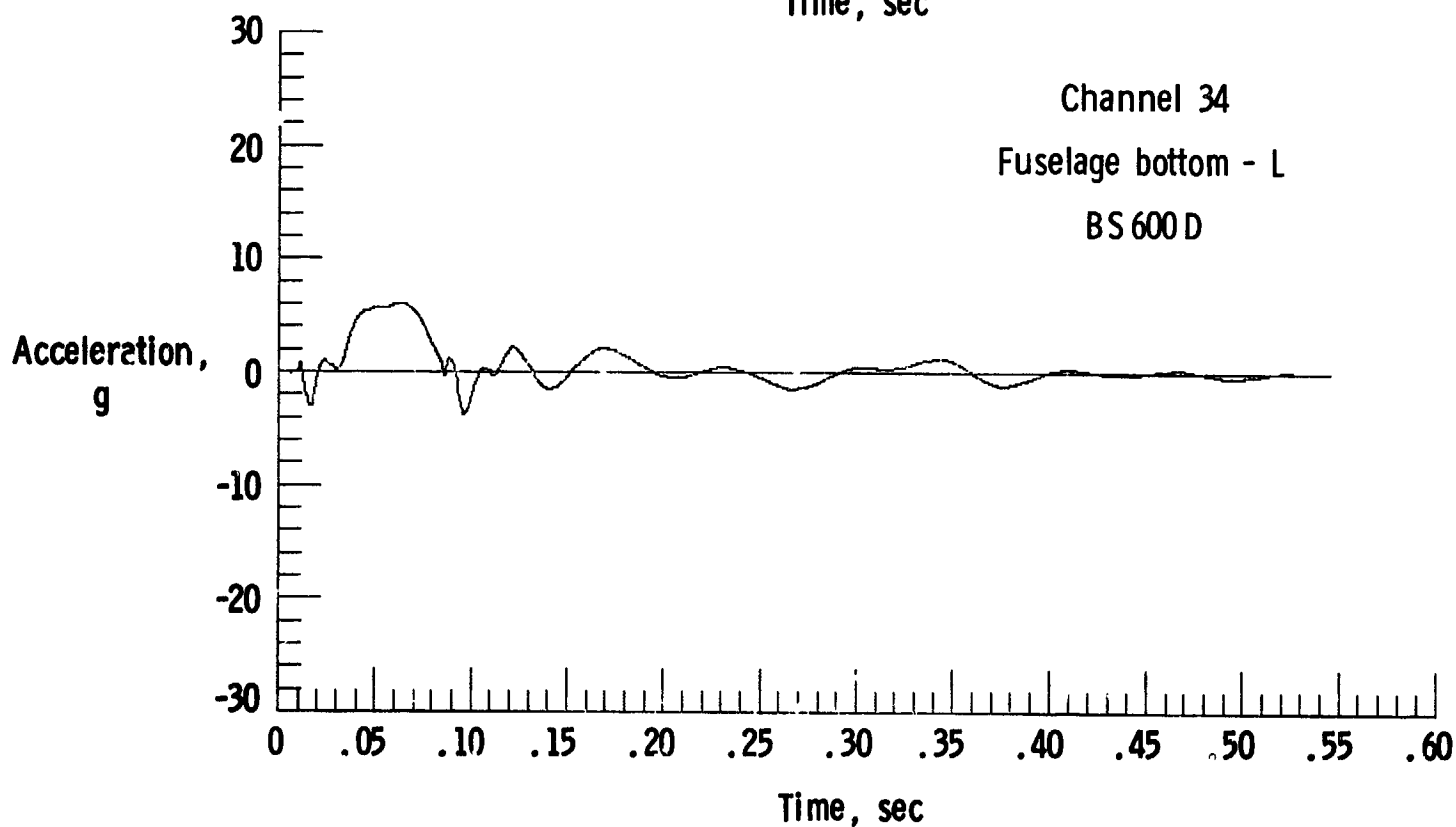
(a) Structural acceleration time histories.
Figure 9.- Acceleration time histories measured on the aircraft structure.

The maximum normal acceleration of the first pulse was measured on the bottom of the fuselage and was approximately 20 g (20 Hz filter) with a time duration of 0.03 sec. Secondary pulses were in the 6 to 12 g range. Normal accelerations measured on the frames approximately one-third and two-thirds the vertical distance between the bottom of the fuselage and floor on the starboard side were characterized by two pulses. The first pulse ranged from 8 to 10 g for approximately 0.03 sec. The acceleration levels dropped soon after the buckling failure occurred and began increasing again as the structure stiffened to a maximum of 10 to 12 g for approximately 0.05 sec (second pulse).

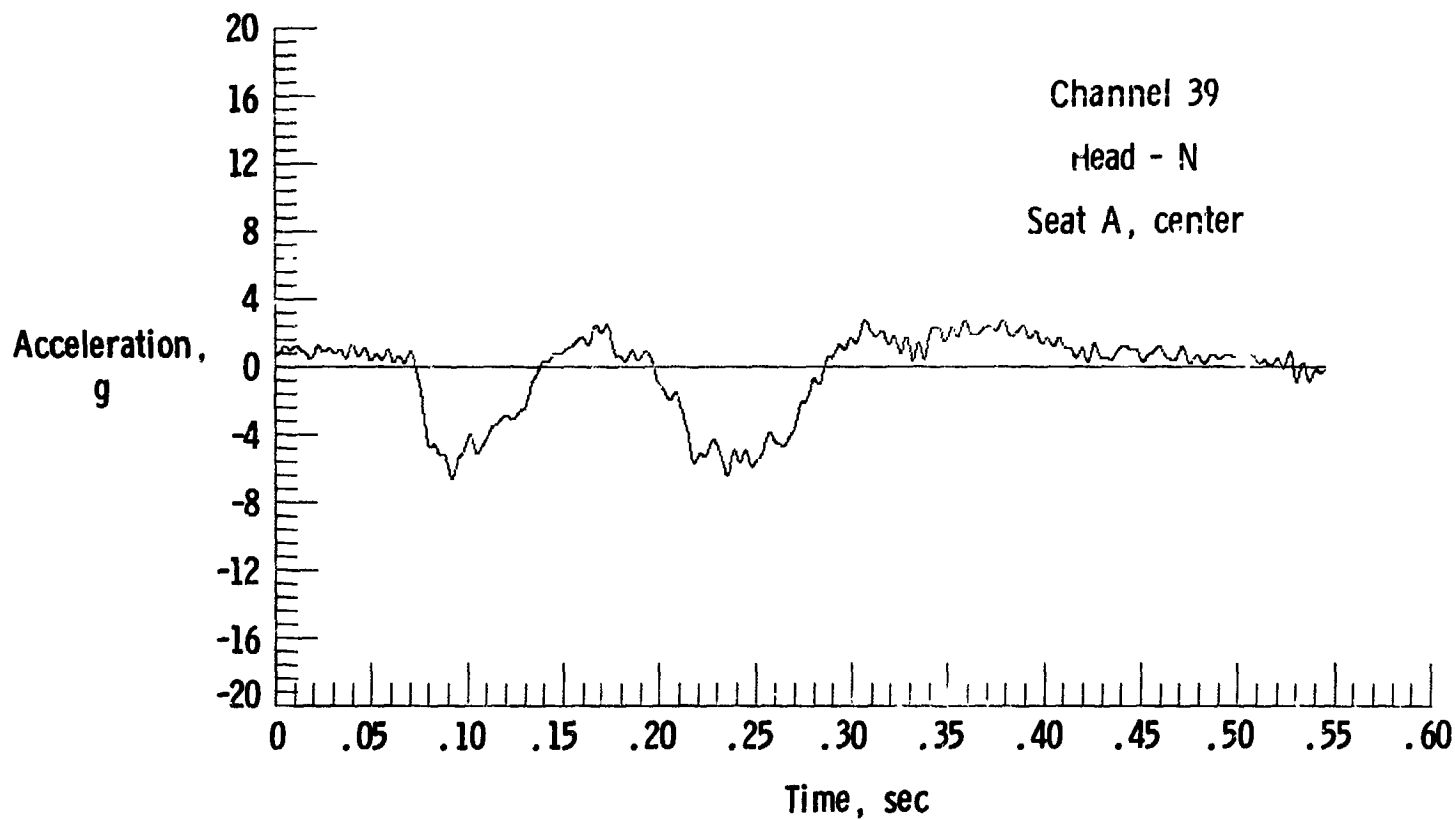
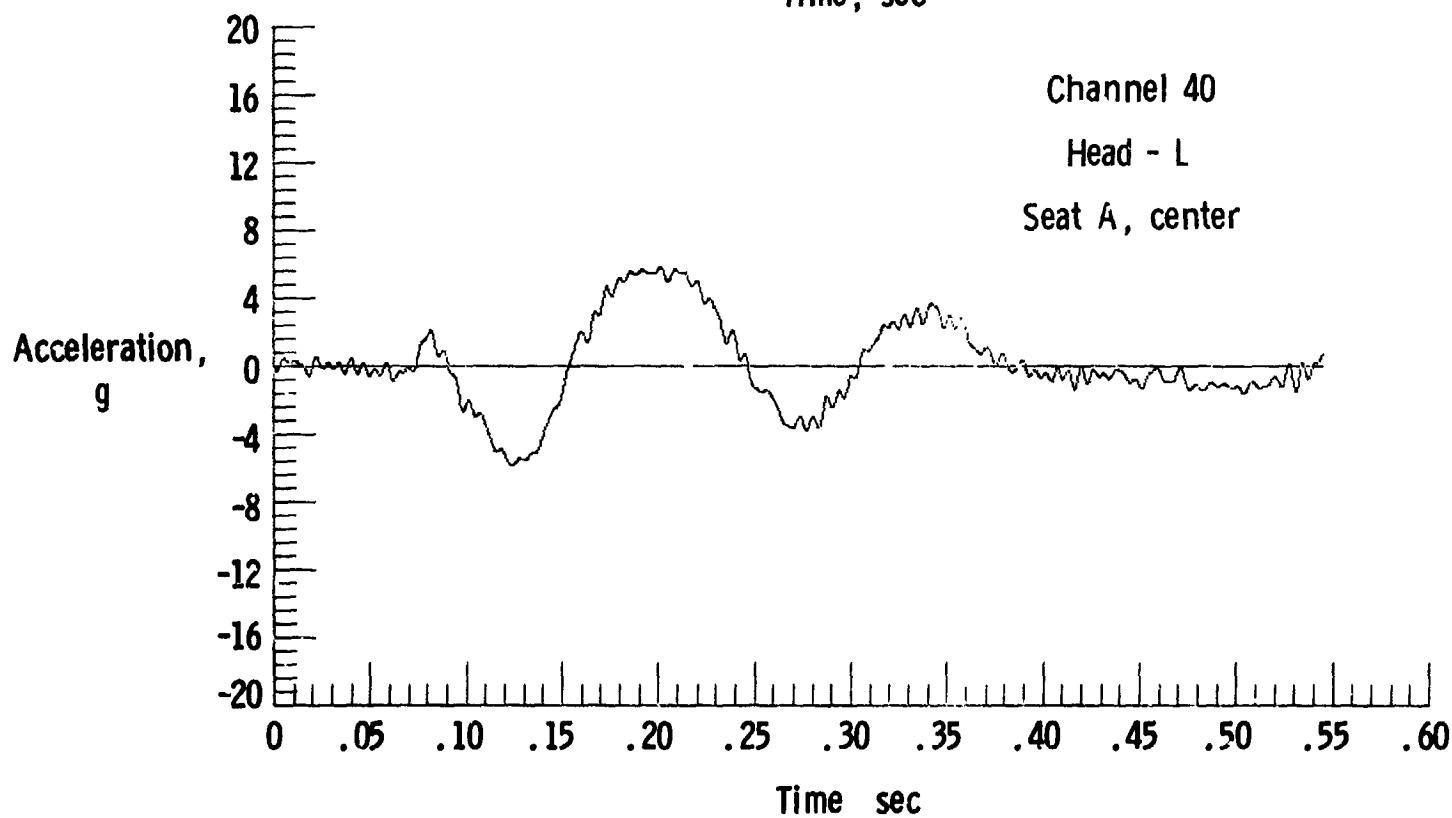
(a) Occupant accelerations.

Post-test inspection showed that the section bottom collapsed inward approximately 2 ft. Preliminary data traces indicated maximum normal accelerations of 20 g at the fuselage bottom, 10 to 12 g at the cabin floor, and 6.5 to 8 g at the dummy pelvises.
